**Flood Control Project Maintenance  
Levee Inspections  
LMA District Cover Sheet  
Spring 2010 Levee Inspection Results**

**Reclamation District No. 0070 Meridian**

Waterway			Bank	Unit Miles
Unit No. 01 Sutter Bypass			Right	8.00

**Levee Inspection Report By Mile - Spring 2010**

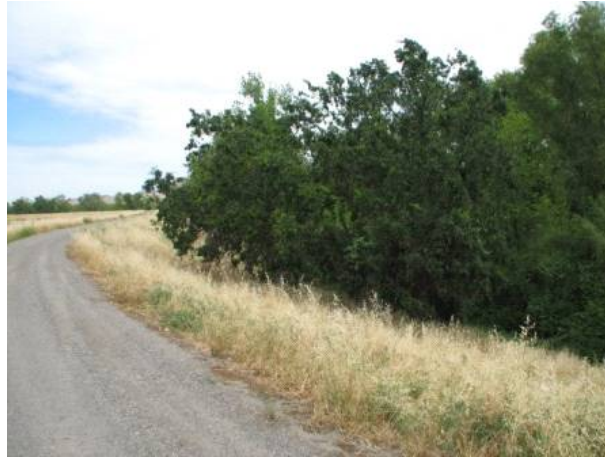
rduffey\_s\_20100622\_058.jpg

Levee Mile Report Line	2
Start Levee Mile	1.33
End Levee Mile	1.33
Location	Water Side
Category	Earthen Levee
Item	Trim / Thin Trees

View of the large oak tree laying on the waterside slope.

LMR No	Levee Mile		Category	Item	Location *	Rating **	Action/Comment	GPS Latitude/Longitude		Issue No. Photo
	Start	End						Start	End	
1	0.95	0.95	Earthen Levee	Encroachments	LS	PO	Buildings	39.146211 ° -121.844551 °	39.146211 ° -121.844551 °	1
2	1.33	1.33	Earthen Levee	Trim / Thin Trees	WS	M	Trim trees to at least five feet above ground level.	39.146025 ° -121.851147 °	39.146025 ° -121.851147 °	2 Y
3	1.55	1.55	Earthen Levee	Trim / Thin Trees	WS	M	Trim trees to at least five feet above ground level.	39.147783 ° -121.854220 °	39.147783 ° -121.854220 °	3

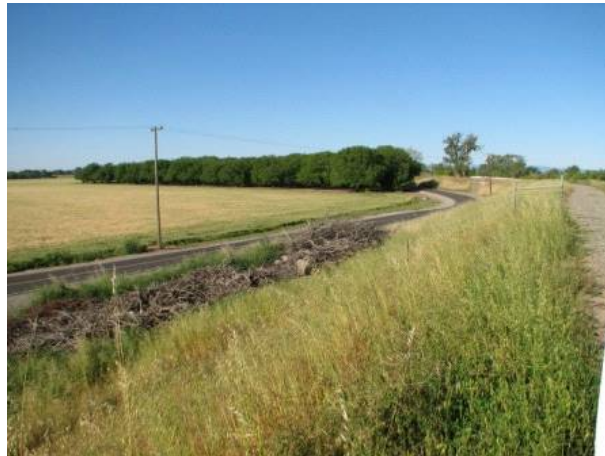
Levee Mile Report Line	2
Start Levee Mile	0.64
End Levee Mile	0.66
Location	Land Side
Category	Earthen Levee
Item	Encroachments
View of the pruning and debris along the landside toe.	
rduffey_s_20100622_059.jpg

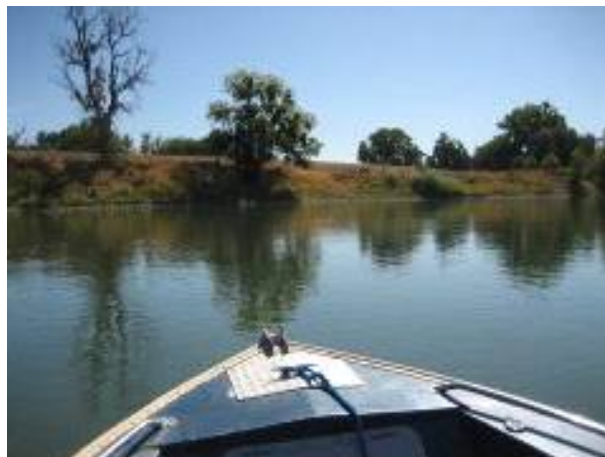
8	8.16	8.26	Supplemental	USACE Erosion Survey	WS	U	Inspector Comments: 2009: no berm, 1.5:1 slope, tree hazards and slumping, clays and silts, 2.86 ft/s [2009 SiteID:SAC_130-0_L]	39.122514 ° -121.910139 °	39.121106 ° -121.909339 °	11 Y
9	10.08	10.47	Earthen Levee	Encroachments	LS	PO	Agricultural Ditch	39.097662 ° -121.896349 °	39.093662 ° -121.892535 °	5

Levee Mile Report Line	8
Start Levee Mile	8.16
End Levee Mile	8.26
Location	Water Side
Category	Supplemental
Item	USACE Erosion Survey
2009: no berm, 1.5:1 slope, tree hazards and slumping, clays and silts, 2.86 ft/s [2009 SiteID:SAC_130-0_L]	
USACE2009_SAC_130-0_L_2009_09_16-D2P13_small.JPG
